**SPRING LAKE DAM**

**CLINTON COUNTY, MISSOURI**

**MO. III22**

**PHASE 1 INSPECTION REPORT  
NATIONAL DAM SAFETY PROGRAM**

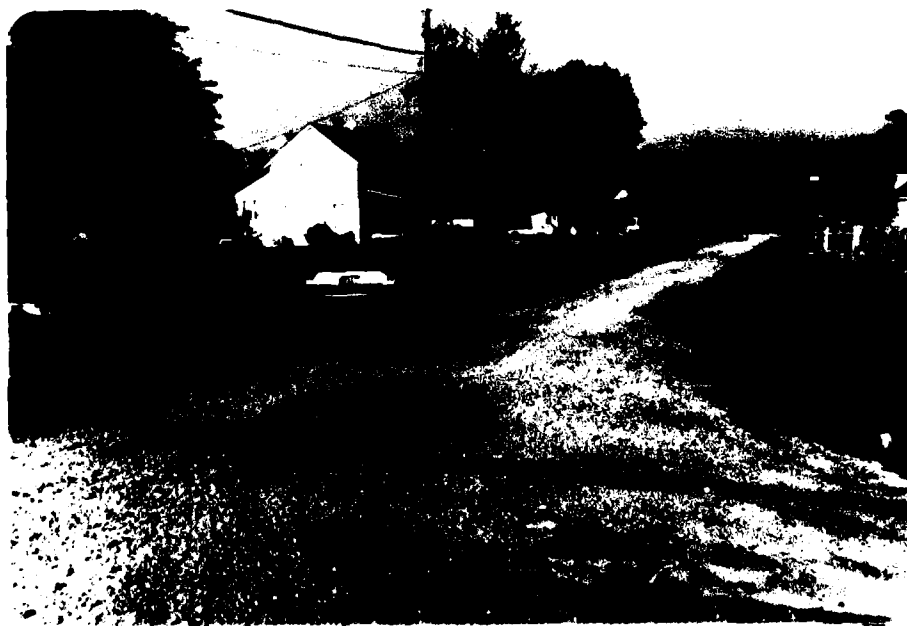
PHOTO NO. 23 - DOWNSTREAM HAZARDS. BUILDINGS IN TOWN OF HOLT.
